# TERRESTRIAL LIDAR INVESTIGATION OF THE 2004 ROCKSLIDE ALONG PETIT CHAMPLAIN STREET, QUÉBEC CITY (QUEBEC, CANADA)

Michel Jaboyedoff, Thierry Oppikofer & Romain Minoia

In nearly 240 years 53 landslides have occurred along the Quebec City Promontory, causing 88 fatalities mainly by rockfalls. In October 2004 a rockfall reached the road close to the 1889 rockfall event which killed 35 people and injured 30 others. Using a terrestrial Lidar scanner (TLS) a 3D image was created. Seven joint sets were accurately determined in agreement with previous research. The TLS imagery permit the estimation of the volumes involved in the past instabilities and analysis of the mechanisms: a rockslide with several joint sets cutting the rock mass into parallelepiped shaped blocks. Furthermore it shows that this location is prone to future rockfall.

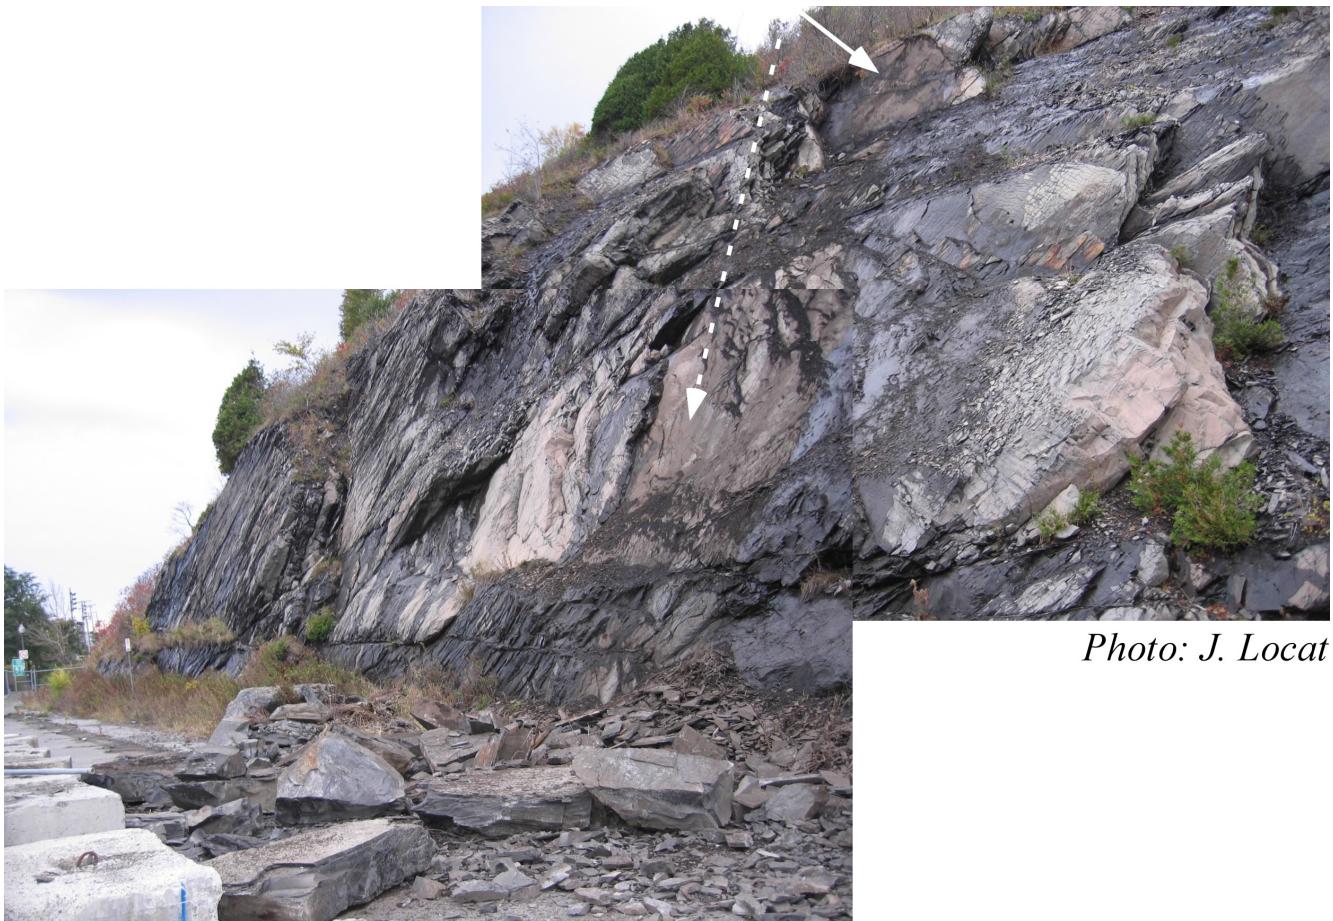
Figure 2. The 2004 failure surface (Locat and Kirkwood, 2004).

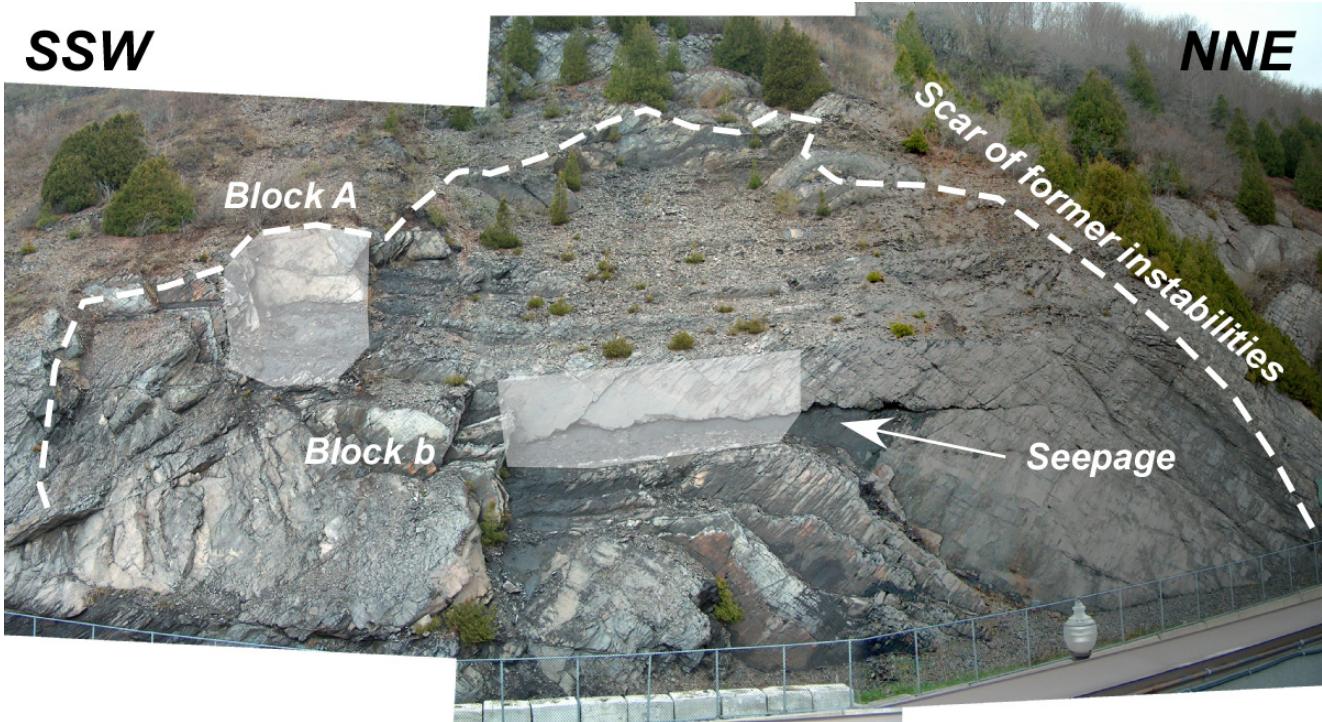
Figure 3. View of recently fallen blocks and former areas of instability including the October 2004 event.

The volume of the block A (Figure 3 and section A in Figures 9) equals (Eq. 2):

A second fresh scar has been identified close to the first one. The volume of block B (Figures 3, 7 and 8) is approximately  $20.5 \text{ m}^3$  (Eq. 3)

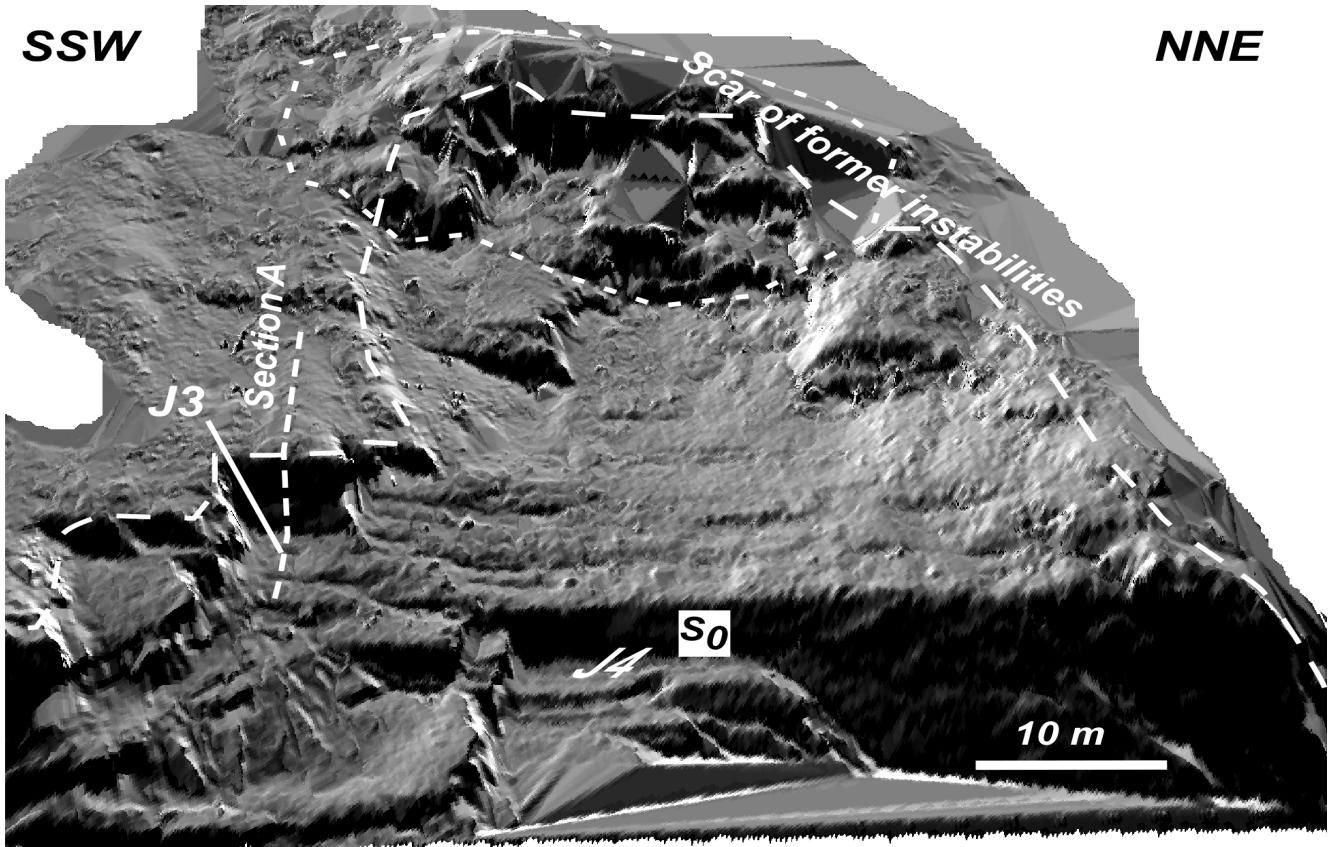
Figure 4. Shaded 3D view of the topography using a 10 cm grid DEM obtained from the cleaned point clouds. Several structures can be observed. The long dashed line indicates the scar limits and the short dashed line shows the potential unstable mass at the top of the slope.

The morphology displayed by the Lidar Imagery shows clearly that the event of 2004 occurred within a zone that suffered several slides (Figures 3 to 7). The scar morphology has limits that are clearly controlled by the joint sets. An important potential unstable mass can be observed at the top of the top of the slope, where some J4 joints probably daylight (Figure 4).

Figure 4 shows clearly that the studied slope posses a long story of small rockfall events. The irregular morphology and the relatively small spacing between joints have created several small rock fall events in the past. The surface of the zone that suffered past rockfall is about 680 m<sup>2</sup>. Based on the Lidar data it appears that the material was removed over a thickness of 5 m. This leads to a total volume of 3400 m<sup>3</sup>. We have obtained previously volumes of 20.5 m<sup>3</sup> and 55 m<sup>3</sup>, which correspond on average to 38 m<sup>3</sup>.

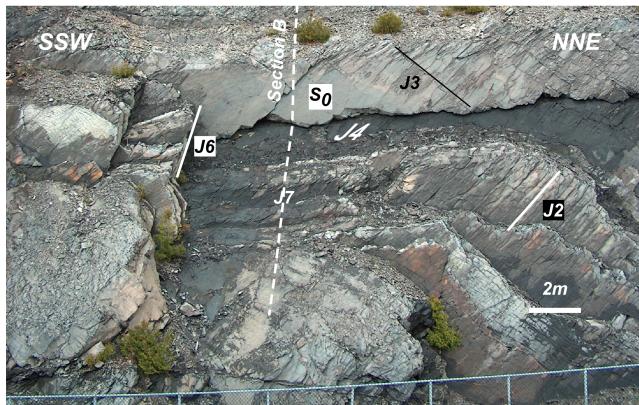
S<sub>0</sub> and J7 act as rear release surfaces and back cracks. J6, J2 and J3 form lateral release surfaces (Figures 5 and 7). These sets delimit parallelepiped shaped blocks and permit a planar sliding mechanism. Joint set J5 described by Baillifard *et al.* (2004a) is not detected, but TLS analysis allows the detection of 2 new discontinuity sets.

Figure 7. Photograph of the October 2004 rockfall. Most of the joint sets derived from laser scanning can be identified.

Figure 6 shows that TLS methods lead to homogeneous discontinuity data sets. These data must be reinterpreted because sets like  $J_1$  and  $J_3$  are certainly the same fabric and probably represent the refraction of a foliation. Such phenomenon is inferred from outcrop inspection in Figure 7. Nevertheless, such a TLS study allows easy identification and characterization of the failure mechanism. As shown by Baillaigé (1893) for the 1889 event, water is suspected to play an important role in the destabilisation of

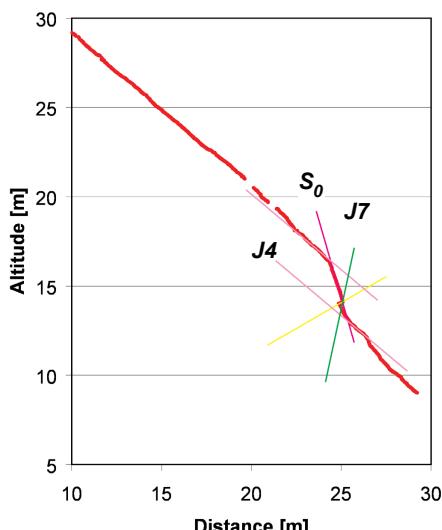
Figure 8. Section B from the Figure 7, showing the different joint sets controlling the slope profile.

$$V_B = 1.8 \text{ m} \times 0.5 \text{ m} / \sin(34^\circ) \times 11.5 \text{ m} = 20.5 \text{ m}^3 \quad [3]$$

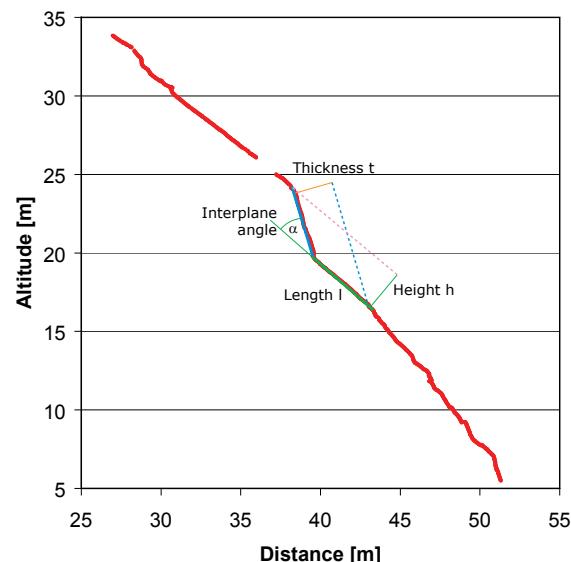
Using the point cloud data it is possible to estimate the volume of the recent rockfall. The volumes are clearly limited by the joint sets; as a consequence the volume can be based on the estimation of their spacing (Figure 9). If ( $h$ ) is the spacing between two joints  $J_4$ , ( $t$ ) the thickness of the bedding, ( $l$ ) the length of the failure surface along the basal surface  $J_4$ , ( $w$ ) the width of the block and  $\alpha$  the angle between  $J_4$  and  $S_0$ , the volume is given by (Eq. 1):

$$V_A = 2.5 \text{ m} \times 2.4 \text{ m} / \sin(34^\circ) \times 5.1 \text{ m} = 55 \text{ m}^3 \quad [2]$$

Figure 9. Section A from Figure 4, showing volume computation.
