**Title:** What happened before the run over? Morphometric 3D reconstruction.

**Authors:** Buck U, Buße K, Campana L, Gummel F, Schyma C, Jackowski C

**Journal:** Forensic science international

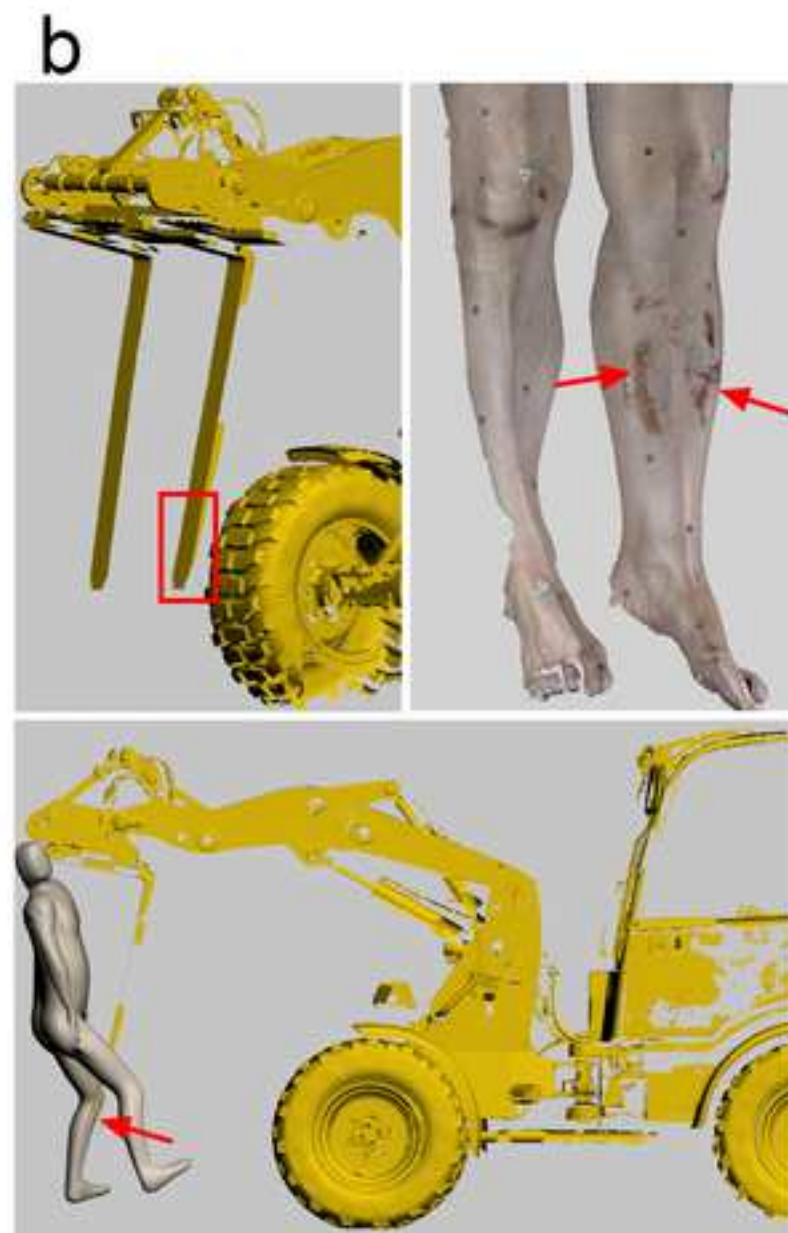
Fig. 1 Case 1: Morphometrical matches.

a) Contused wound on the left side of the deceased's forehead (red arrows), which matches with a part of the wheel loader's fork carrier (red circle). Reconstructed 3D view for this match.

b) Part of the wheel loader's fork arms (red box) which matches with the skin abrasion on the left lower leg of the deceased (red arrows). Reconstructed 3D view for this match.

Thanks to morphometric 3D reconstruction an allocation of the documented findings and traces to the primary hit, to the fall itself and to the run over was possible. The contused wound on the left side of the deceased's forehead could be assigned to an impact of the left side of the fork carrier's top edge via its dimension and shape (Fig. 1a). Moreover, the shaped skin abrasion at the inner side of the left lower leg matched with the fork arm in terms of size and shape (Fig. 1b). These injuries indicate a hit from the man's right side while crossing the street from left to right from the driver's perspective. Furthermore, the height of the fork carrier at the time of collision could be reconstructed based on the location of the injuries caused by the impact (Fig. 2a).

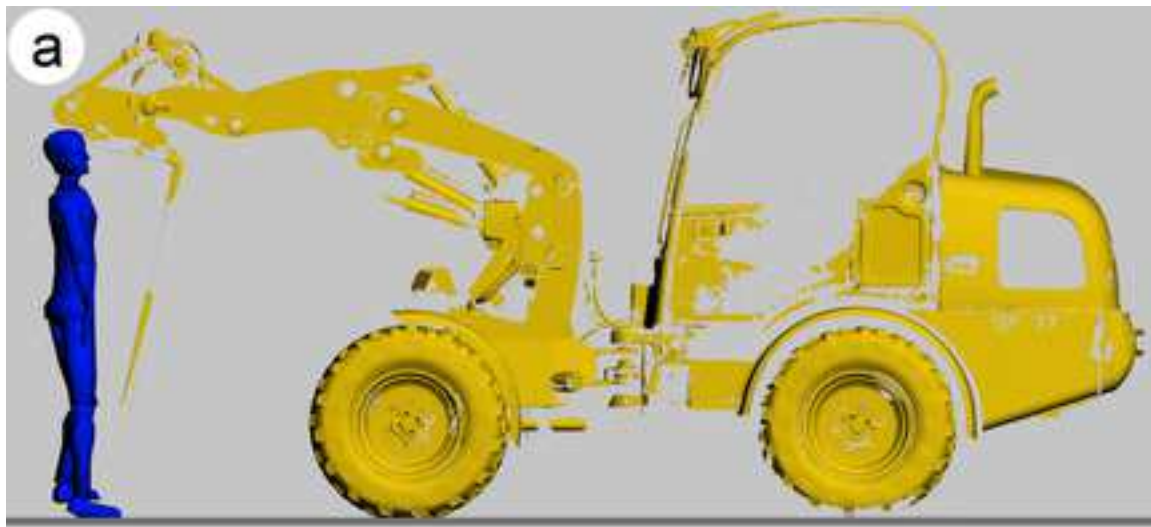
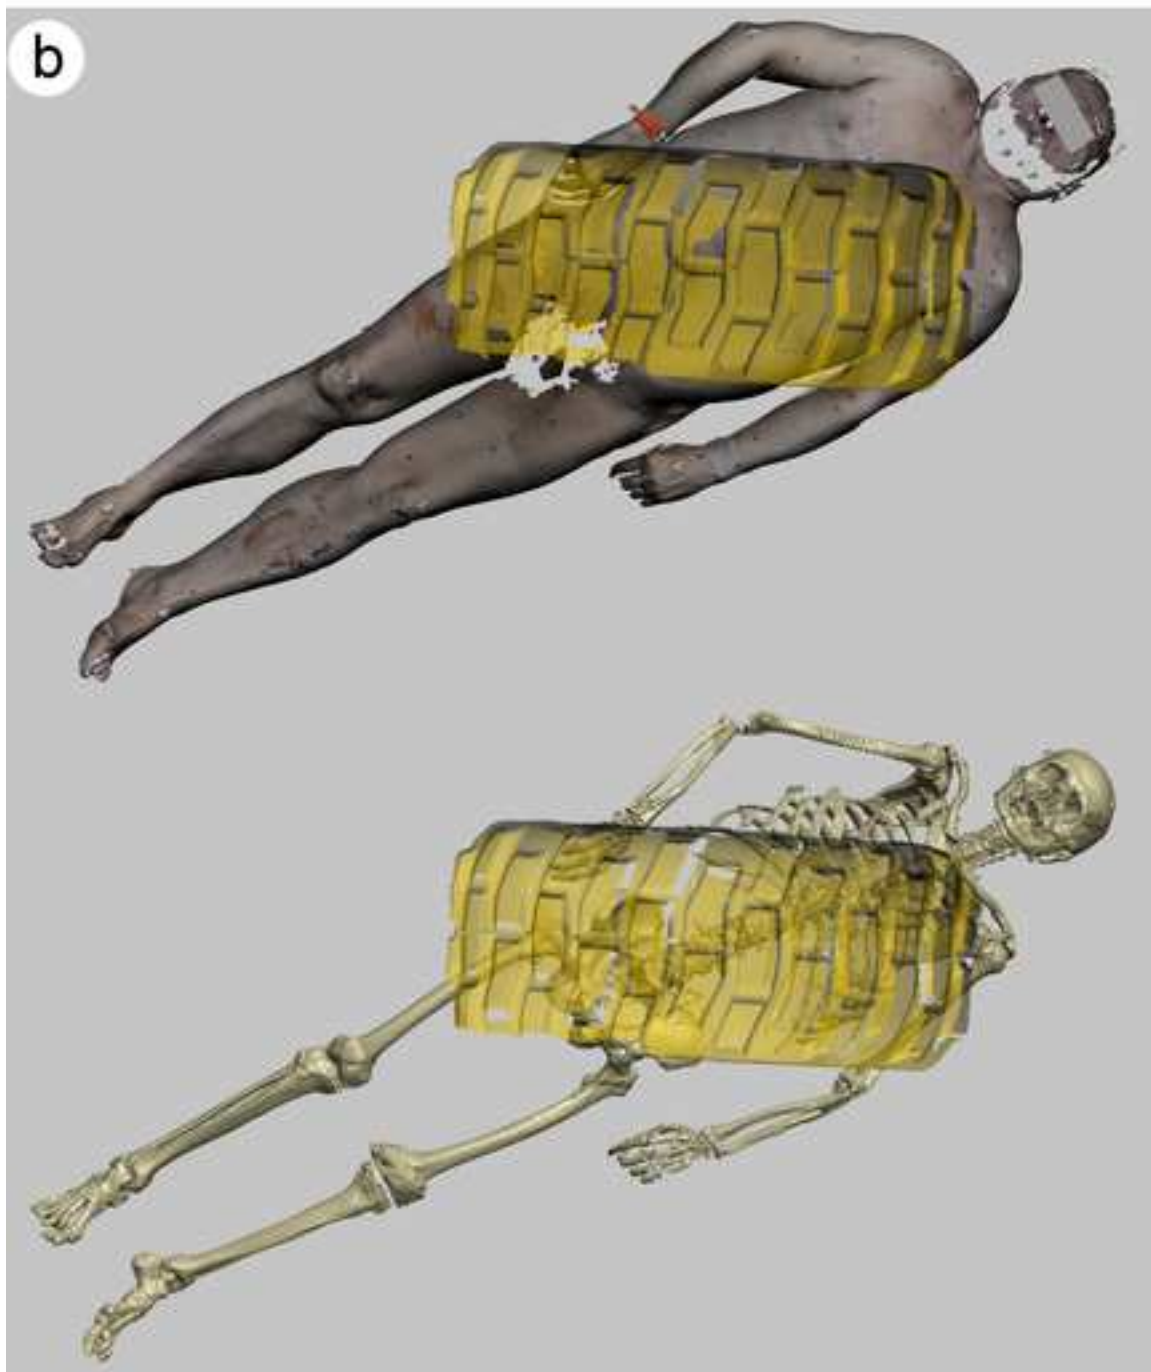
Fig. 2 Case 1: Reconstruction results for the position of the fork carrier of the wheel loader and the run over

a) Reconstructed position of the wheel loader's fork carrier during the accident.

As a consequence of this first impact the deceased fell backwards on his occiput which resulted in a burst fracture system and the contusion respectively hematoma at the back of his head. Furthermore, the reconstruction showed that the deceased was lying on his back when he was rolled over by the left front wheel of the wheel loader (Fig. 2b), which caused the trauma of the trunk.

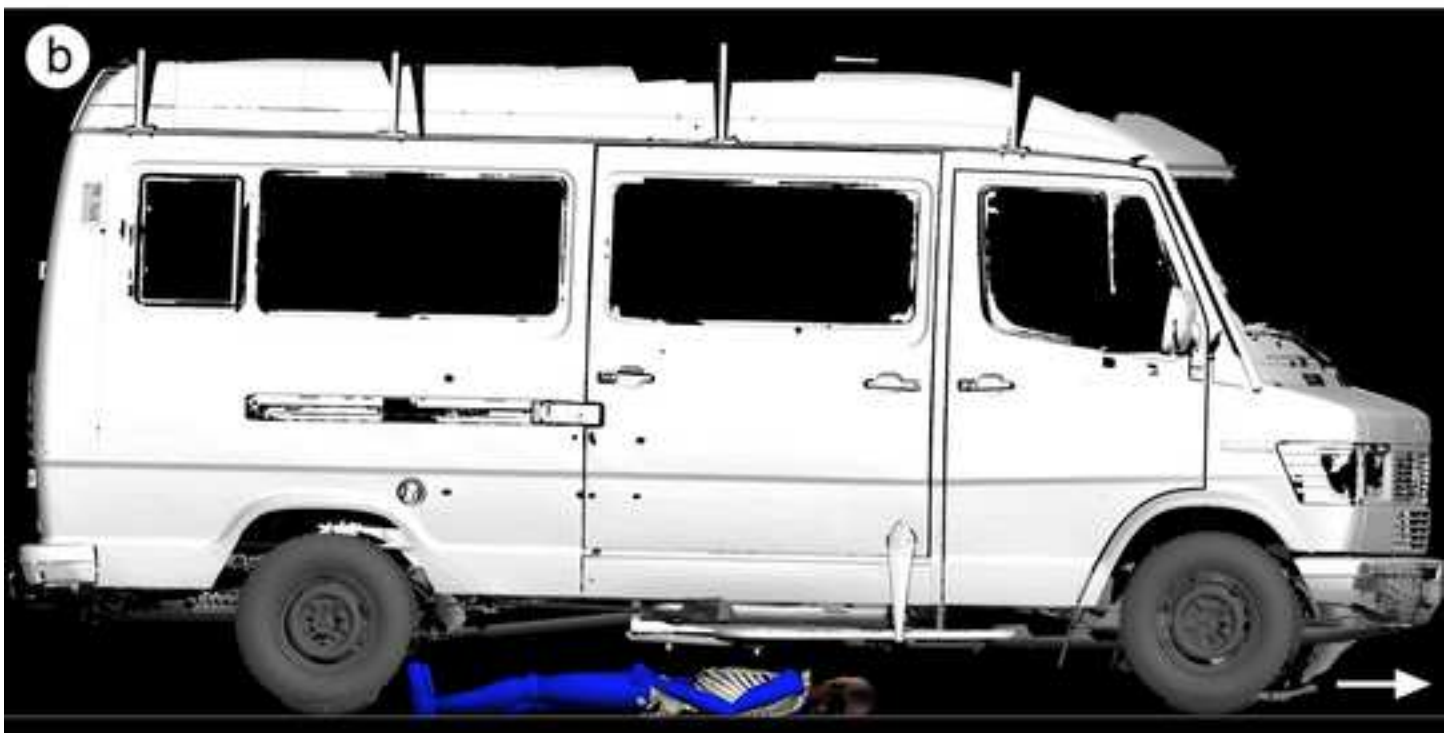
Fig. 3

b) Case 2: 3D reconstruction of the accident with the man lying under the transporter before the run over

In further sequence of events the man got drawn under the car and was rolled over by the right rear wheel in the direction of the longitudinal axis of his body while lying supine on the ground (Fig. 3b). It was possible to assign the degloving (décollement) [31] of the right lower leg, a haemorrhage into the tissue of the small pelvis, multiple right rib fractures, the patterned injury in the face and the hinge fracture of the skull to the run over (Fig. 4).
