Interpretation of laser scanner 3D data used to determine circular failure surface of shallow landslides

Oppikofer, T., Jaboyedoff, M., Baillifard, F., Pedrazzini, A. and Travelletti, J.

University of Lausanne, Institute of Geomatics and Analysis of Risk (IGAR), Amphipole, CH-1015 Lausanne, Switzerland, email: Michel.Jaboyedoff@unil.ch

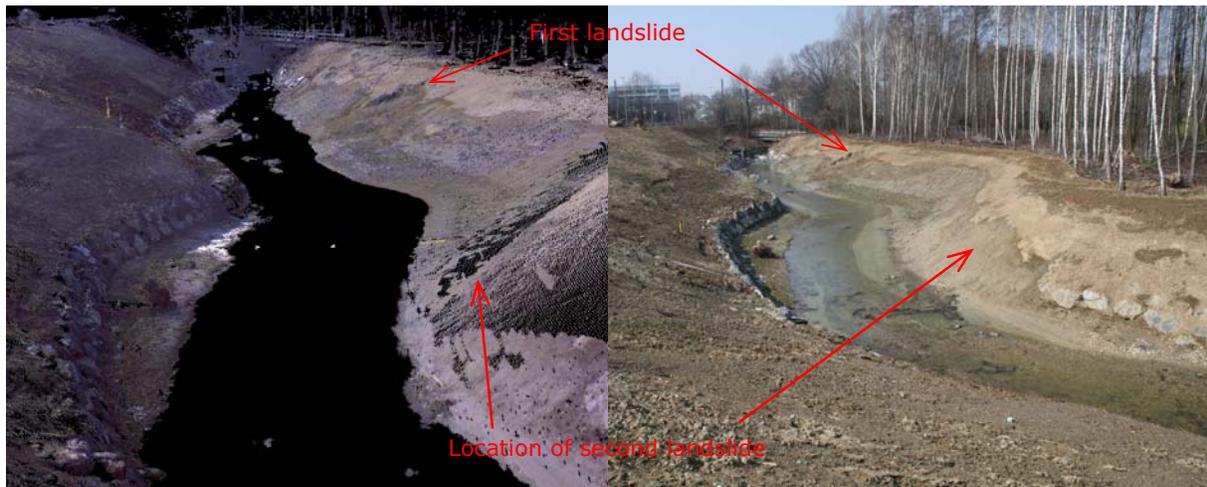
Figure 1: Views of the Sorge River to the West (taken on March 16th 2006). The point cloud of the laser scanner and the photograph show the area of the remedial works that were done in 2005. The scar of the first landslide is also shown.

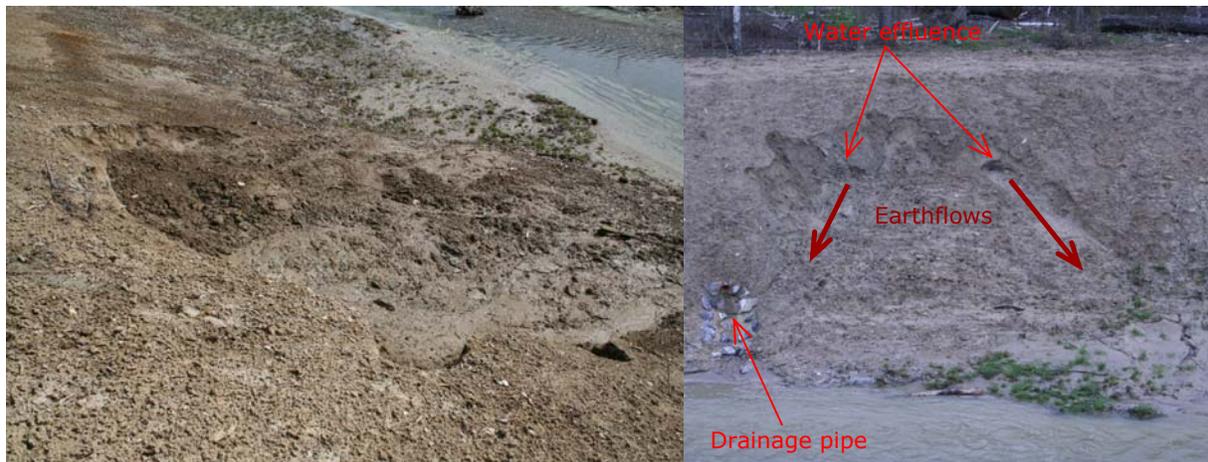
Figure 2: Photographs of the pre-existing landslide (left: taken on March 16th 2006; right: taken on April 12th 2006). The circular failure surface, the landslide's head and foot are visible. The main body of the slide is wet, indicating arrival of groundwater. Water effluences are observable on the picture taken on April 12th 2006. They probably caused some small earthflows.

The first landslide occurred before March 16th 2006. The scar of this landslide is perfectly circular and has a maximal height of 1.3 m. The body of the landslide shows a typical morphology of a rotational landslide with a planar landslide head and an accumulation of soil material in the foot part (Figure 2).

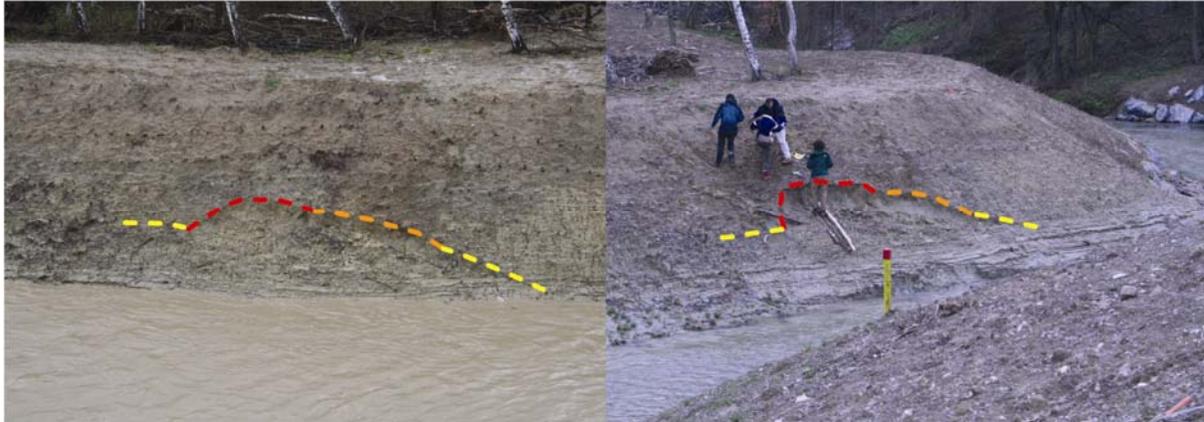
Figure 6: Photographs of the second landslide (left: taken on 10th of April 2006 during the flooding; right: situation on April 12th 2006). The main scarp (red), the secondary scarp (orange) and the minor scarps (yellow) are discernable on both pictures. The landslide continued its rotational movement in the interval of the two pictures.

The second landslide in the eastern part of the study area occurred in the period between the two scanning campaigns (Figure 6). It was probably caused by the intense rainfall event of 8th to 10th April 2006 and the increased river flow rate. The landslide is composed of a main rotational slide and a smaller secondary rotational slide. Small scarps are also observable on both sides of the landslide. The main scarp is circular and reaches a height of 0.6 m in the central part. The lateral extent of the landslide is approximately 5.5 m. Apparently, the landslide initiated already during the flooding of 8th to 10th of April 2006, but displacements continued after the decrease of the river's water table (Figure 6).
