Reconstructing past flood events from geomorphological and historical data. The Giéthro outburst flood in 1818

C. Lambiel , E. Reynard , P. Corboz , E. Bardou , C. Payot & B. Deslarzes

To cite this article: C. Lambiel , E. Reynard , P. Corboz , E. Bardou , C. Payot & B. Deslarzes (2020) Reconstructing past flood events from geomorphological and historical data. The Giéthro outburst flood in 1818, Journal of Maps, 16:2, 500-511

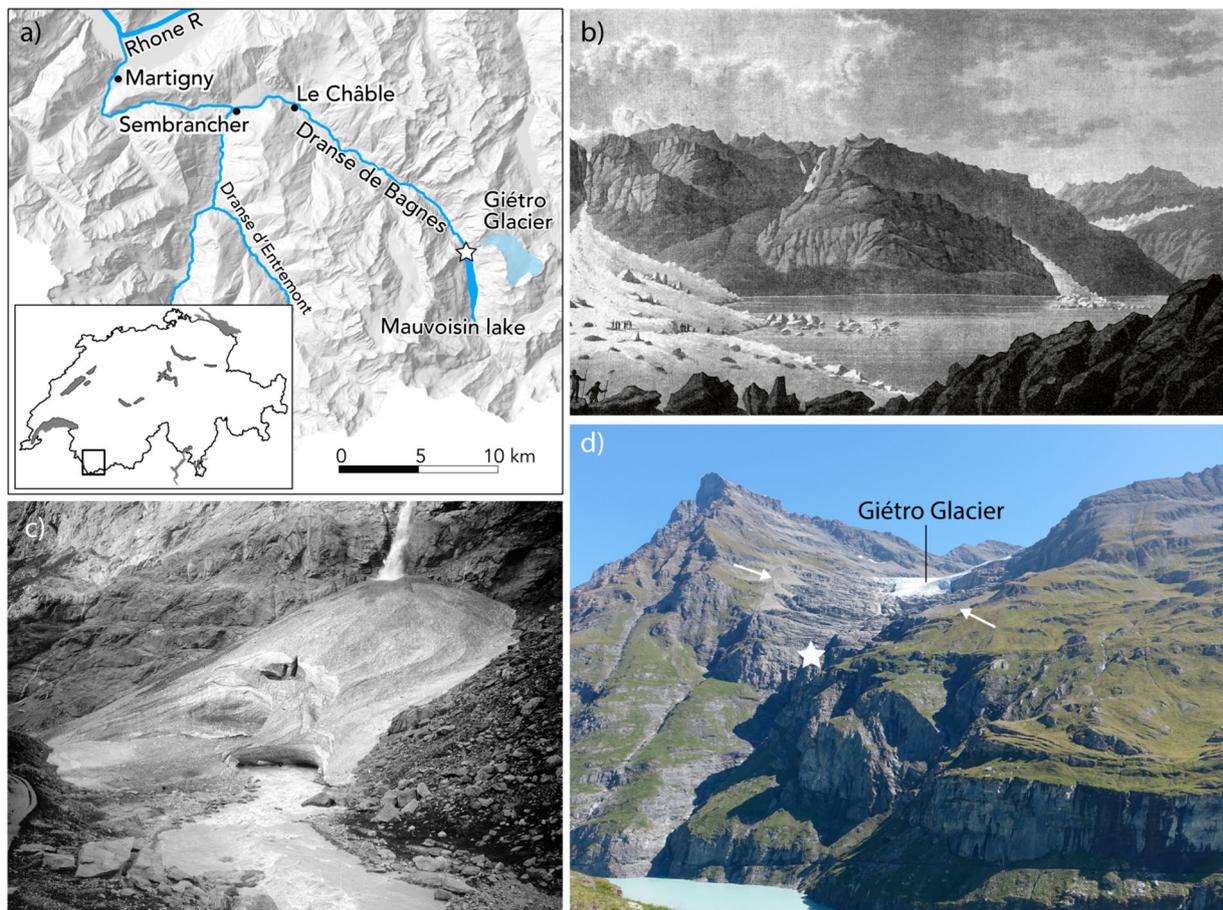
Figure 1. (a) Location of the Bagnes valley in the Swiss Alps, with the Giétro glacier and the location of the 1818 ice cone (star). (b) The ice cone (regenerated glacier) and the lake in spring 1818. Unsigned drawing, attributed to Théophile Steinen. (c) The ice cone in 1920. Photographer unknown © ETH-Bibliothek Zürich, Bildarchiv. (d) View on the Giétro glacier in August 2017, with the Little Ice Age moraines (arrows) and the approximate frontal position of the glacier in 1818 (star). Downside is the Mauvoisin dam lake. Photo C. Lambiel.

The Giétro outburst flood was due to the break-up of an ice dam built by the Giétro glacier in the Bagnes valley (Swiss Alps) (Figure 1(a)). In the early nineteenth century, the terminus of the glacier reached steep rocky slopes (Figure 1(d)), from where ice avalanches triggered to build eventually a regenerated glacier down valley (Figure 1(b,c) + Main map). Following the Tambora eruption in April 1815 and the consecutive ‘Year without summer’ in 1816 (Brönnimann & Krämer, 2016; D’Arcy Wood, 2015), the regenerated glacier grew rapidly, reaching a volume of ~10 million cubic meters in Spring 1818 (Funk et al., 2019). This blocked the flow of the Dranse de Bagnes River, which led to the formation of a lake of 30 million cubic meters (Escher de la Linth, 1818).

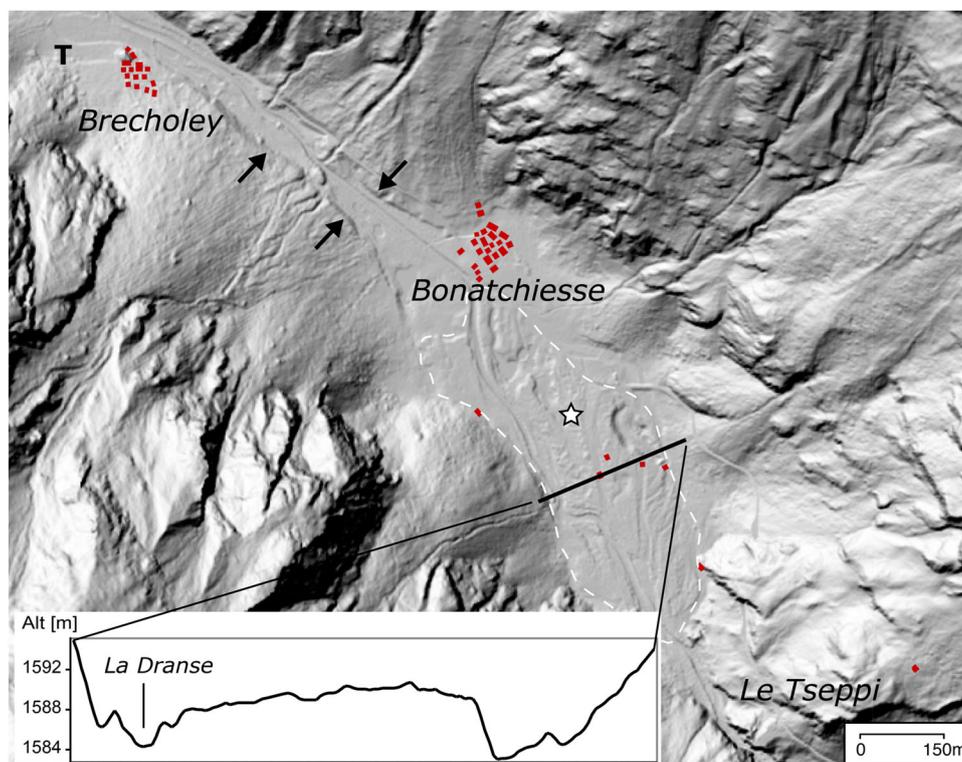
Figure 2. Shaded DEM (SwissAlti3D) of the Bonatchiesse sector. Well visible is the alluvial fan with the channels built by the outburst flood southeast of Bonatchiesse (dotted white line), as well as the two terraces (black arrows). The star shows the location of the boulders on Figure 3. The topographic cross-profile through the fan shows the thickness of the deposits. Red squares are the current buildings. Reproduced by permission of swisstopo (BA19054).

The first reference to the course of the wave in historical documents concerns a 25 m deep gorge located 1 km downstream of the ice dam at Mauvoisin, which led water raise up to 8 m higher than the gorge and the destruction of the first bridge (See [Main map](#)). One kilometer downstream at *Le Tseppi*, a second 30 m deep gorge had the same influence on the wave, accelerating the current. Just downstream, the widening of the valley in the sector of Bonatchiesse caused the slowing down of the water and consecutively the deposit of large amounts of sediments. The hamlet of Bonatchiesse was completely destroyed by the wave (70 buildings). Particularly spectacular is the boulder accumulation on about 15 ha in the center of the valley ([Figures 2 and 3](#)). Their petrography excludes any rockfall deposit and indicates thus that the blocks must have been transported from upstream. The DEM shows that the blocks are located at the surface of an alluvial fan with several relict channels ([Figure 2](#)), which excludes any glacial transport and indicates thus a fluvial deposit. Given its old facies (well-developed vegetation cover with forest, presence of lichens on the boulders), the deposit can be attributed to the Giéthro event. The elevation difference between the current river bed and the highest point of the fan is

about 7 m. This value gives us an indication on the maximum water depth during the flood. Just downstream of Bonatchiesse the valley narrows and two 10 m high terraces are visible on each side of the river (Figure 4). They probably indicate the maximum water level reached by the flood, which may have been 15 m here. This can be considered as a maximum value, as no building was destroyed in Brecholey, a hamlet located just above the terrace on the left side of the Dranse River. The combination of all these data allowed the outline of the flood to be delimited with a high level of certainty in this sector (Figure 5).

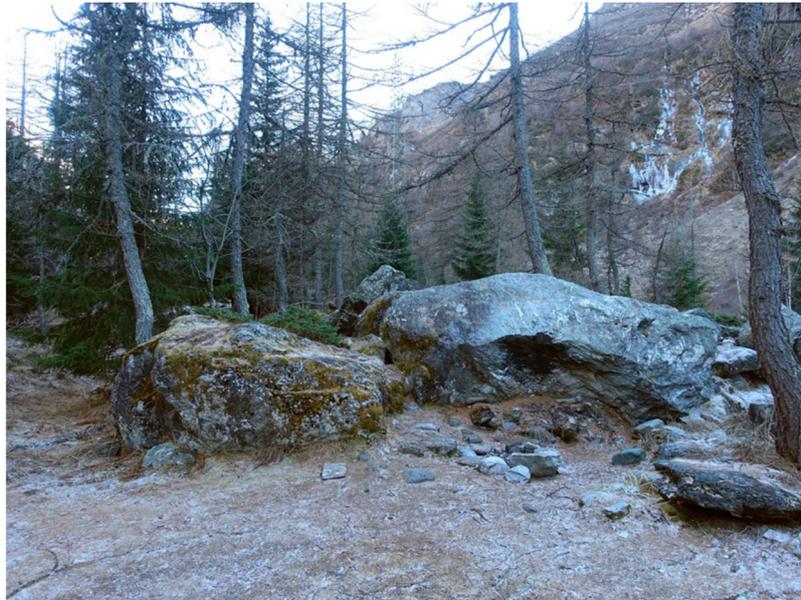
Figure 3. Boulders present in the Bonatchiesse sector on the alluvial fan (See Figure 2 for location).

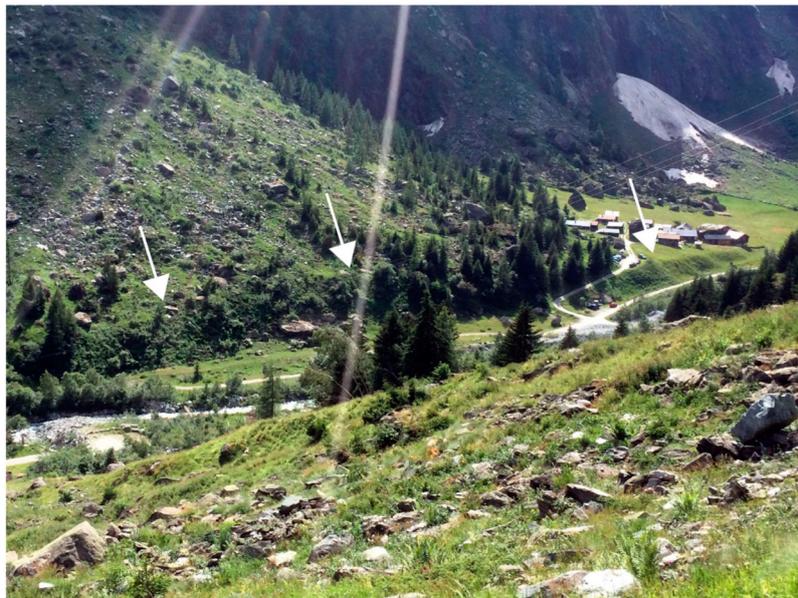
Figure 4. Erosion edge upstream of Brecholey that shows the probable maximum water level during the event (See Figure 2 for location).

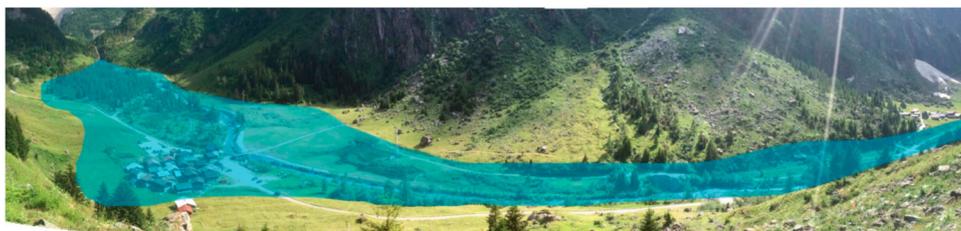
Figure 5. The flood extent in the Bonatchiesse and Brecholey sector.

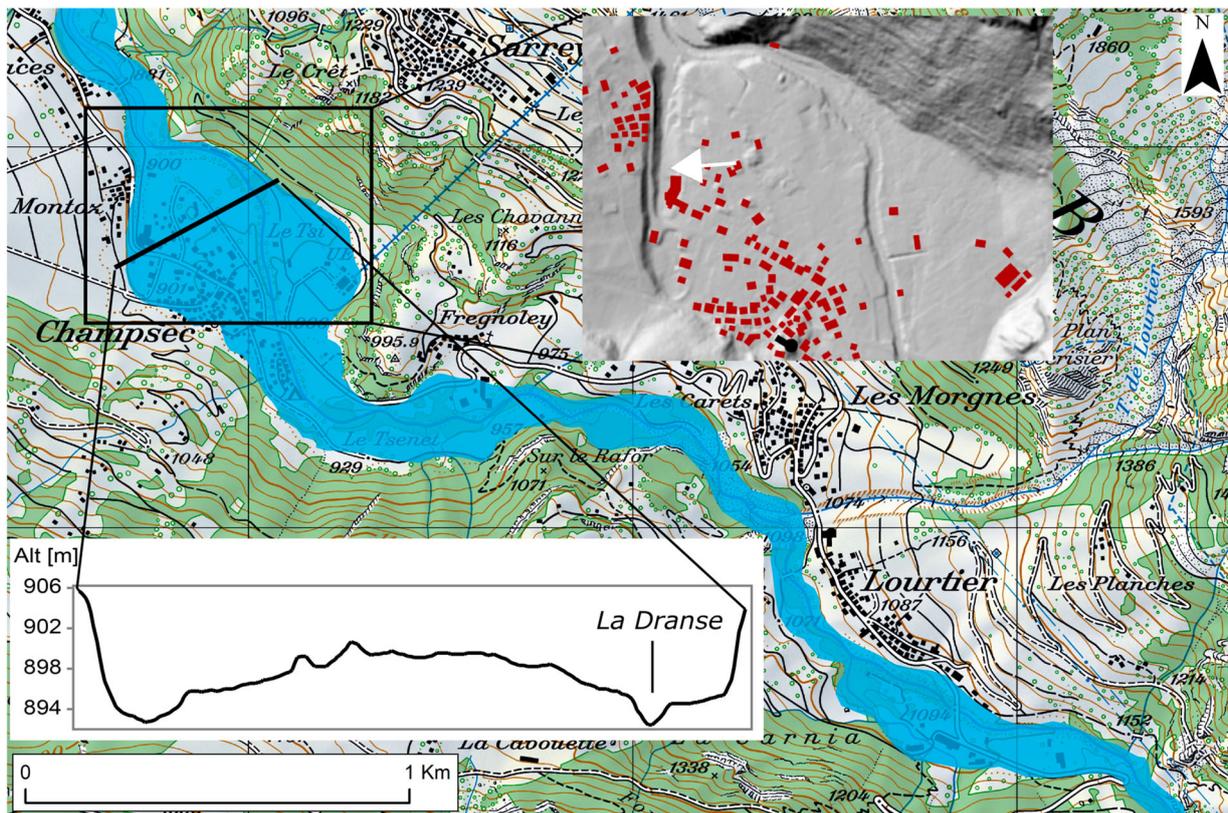
Figure 6. The flood extent between Lourtier and Champsec. The sketch shows the topographic cross-profile through the Champsec plain, from the Versègères alluvial fan (near La Montoz) up to the current river bed of the Dranse River to the ENE, with the convex section due to the sediment deposits. The shaded DEM shows nicely the dry valley (arrow). Reproduced by permission of swisstopo (BA19054).

The most affected village is Champsec, where 77 buildings were destroyed. Unlike Bonatchiesse, this village was inhabited all year long. The valley is relatively large and flat here, which permitted the deposition of a large amount of sediments, as shown by the convex cross-profile and the presence of boulders in the middle of the valley (Figures 6 and 7). Maximum water depth can be estimated to have been 6 meters, according to

the cross-profile. North-West of the village, a small dry valley probably indicates that the flood separated into two branches after having deposited the main sediment load, one following the current river channel and the other one passing through the village before getting along the base of the large Versegères alluvial fan. Given the large size of this dry valley, it is however probable that it had been already dug by former outburst floods, in particular the one of 1595. This interpretation is attested by a letter written by an observer the day after the disaster, which mention that the river was digging below the hamlet of *La Montoz* that was about to collapse (Hugon-Duc, 2018, p. 21).

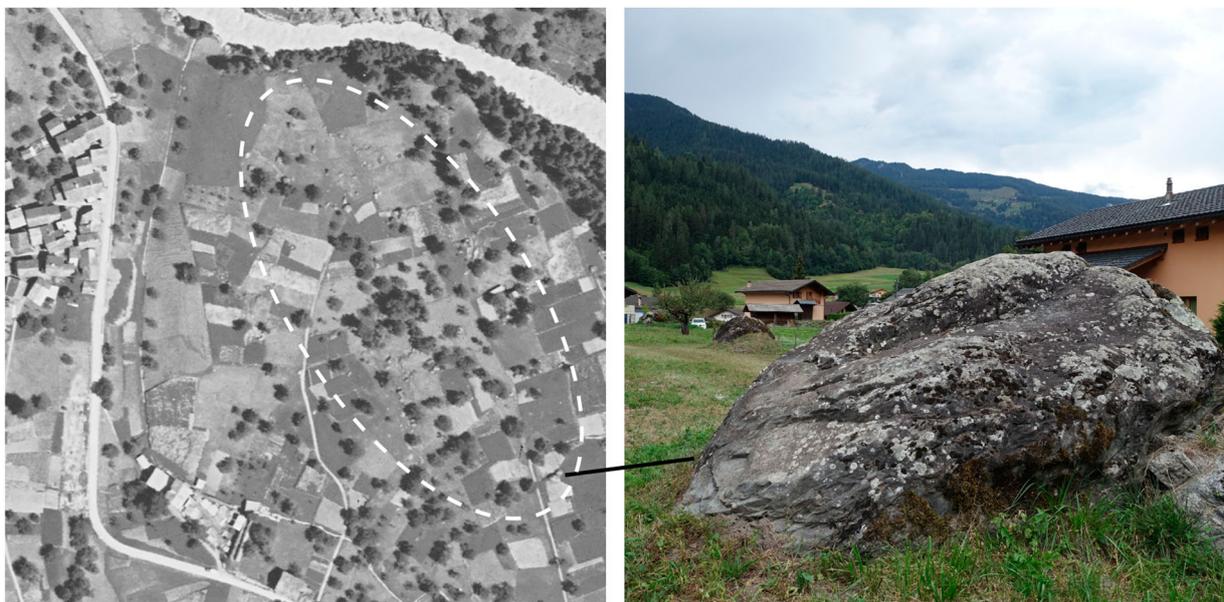
Figure 7. Left: Location of the boulders deposited in Champsec during the outburst flood (dotted line). Aerial photography of 1935, reproduced by permission of swisstopo (BA19054). Right: Close view on one boulder.

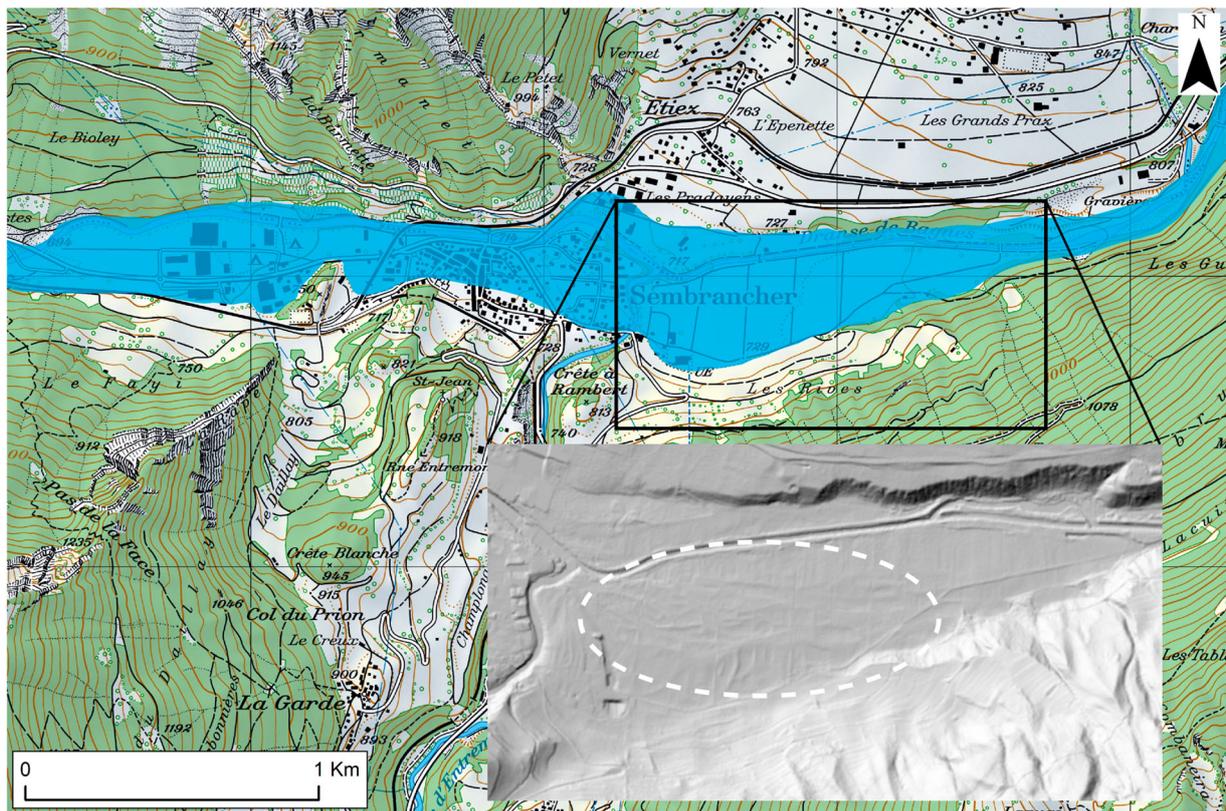
Figure 8. The flood extent in the Sembrancher sector. The shaded DEM shows well the morphology of the fluvial deposits East of the village (dotted line). Reproduced by permission of swisstopo (BA19054).

Downstream, the sector of Sembrancher is relatively wide and flat, which caused the flooding of large surfaces. On the agricultural plain located at the East of the village, a micro topography made of elongated mounds separated by shallow channels is particularly well evidenced by the shaded DEM (Figure 8). This

indicates the significant deposition of sediments. Maximal water depth must have been 6 meters here. A systematic inventory of the damages for this village
