# Cascading processes in a changing environment: Disturbances on fluvial ecosystems in Chile and implications for hazard and risk management

B. Mazzorana<sup>a,b,h,\*</sup>, L. Picco<sup>c,e,h</sup>, R. Rainato<sup>c</sup>, A. Iroumé<sup>d,h</sup>, V. Ruiz-Villanueva<sup>f,g</sup>, C. Rojas<sup>a</sup>, G. Valdebenito<sup>e,h</sup>, P. Iribarren-Anacona<sup>a</sup>, D. Melnick<sup>a,b,i</sup>

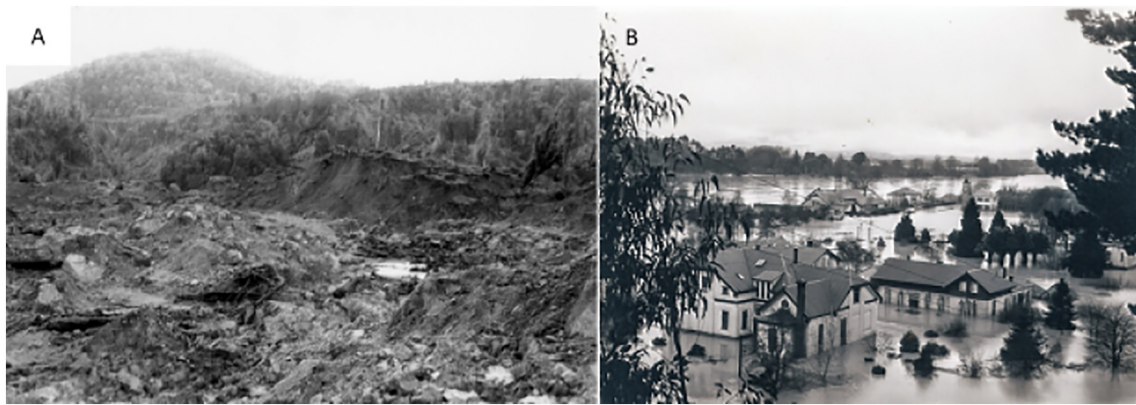
**Fig. 3.** The “Riñihualzo” - Triggers and effects. Panel A: Detailed view of the multitrotational landslide damming the Riñihue lake (image on courtesy: ex Instituto de Geociencias, Universidad Austral de Chile); Panel B: Flooded urban sectors of the city of Valdivia because of the Riñihualzo (image on C. Rojas' courtesy).

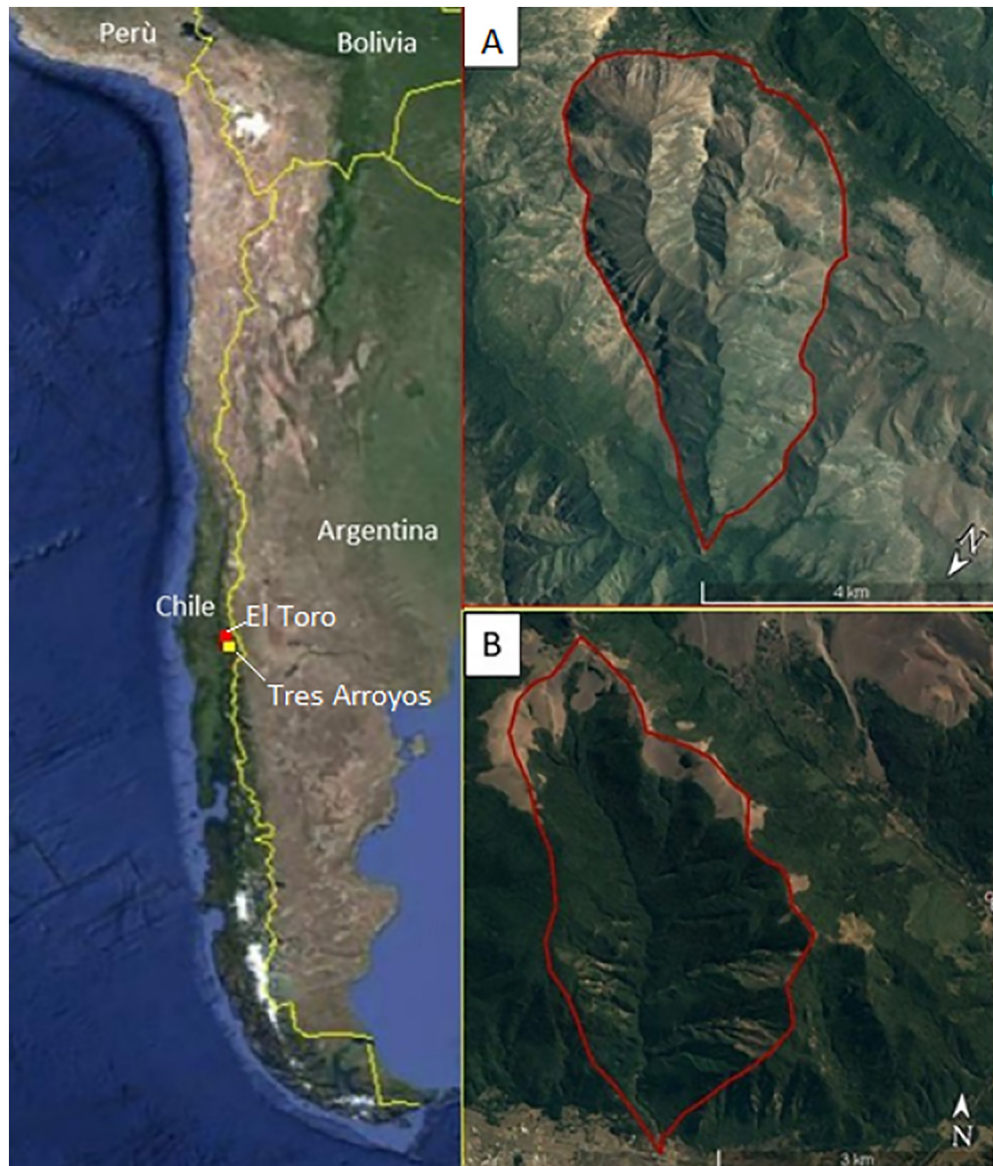
**Fig. 6.** The El Toro and the Tres Arroyos river basins. Localization of the El Toro Basin (red rectangle, and box A), and the Tres Arroyos basin (yellow rectangle, and box B) in Chile. (For interpretation of the references to colour in this figure legend, the reader is referred to the web version of this article.) (Images taken by Google Earth).

and to the anthropogenic environments. However, it must be underlined that wildfires are also a fundamental element in the natural living cycle for many native forest species, shaping the forested landscape (Gonzalez et al., 2005). In fact, as reported by many authors (Burns, 1993; Gonzalez et al., 2005; Comiti et al., 2008), the most common Chilean native species take advantage from wildfires to reproduce themselves. These species are mainly the *Nothofagus* spp. (i.e., *Nothofagus dombeyi*, *Nothofagus nervosa*) and the *Araucaria* (i.e. *Araucaria araucana*). Moreover, 2.7 million ha are covered with exotic fast-growing species established for wood production purposes; also these species, notably *Pinus radiata* and *Eucalyptus* spp., are susceptible to wildfires. Considering these aspects, it appears of fundamental importance to consider the potential effect that wildfire events can exert on river catchments. Here we present the main effects of two different fire events that severely affected two river basins of the Araucania District in central Chile (see Fig. 6).

The Toro basin (1750 ha) is located within the Malleco Forest National Reserve (see Fig. 6; Panel B). It was, until 2002, almost entirely covered by old-growth native forest mainly composed by *Nothofagus* spp., when an impressive wildfire burned around 88% of the native forest, while the other 12% was severely affected. Contrarily to the Tres Arroyos basin, the El Toro basin do not present yet hillslope instabilities (Iroumé et al., 2015). The same area was hit, again, by a large wildfire in 2015 which destroyed natural regeneration.
