Case report

Locked 90°-double plating of scapular spine fracture after reverse shoulder arthroplasty with union and good outcome despite plate adjacent acromion fracture

We report the case of a 74-year-old woman who sustained a scapular spine (SS) fracture after a fall 4 weeks after reverse shoulder arthroplasty (RSA). Open reduction and internal fixation (ORIF) with locked 90°-double plating resulted in union of the SS fracture with a good outcome (subjective shoulder value: 80%; Constant score 67; 1 year) despite of an adjacent lateral acromion fracture 3 weeks after ORIF. This is the second description in the literature of a successful double plate ORIF with union of an SS fracture after RSA. SS fractures are known to lead to poor RSA outcomes with a high mal-union rate and non-union rate. We describe the positioning of the plates and technical steps for successful ORIF to avoid complications, discuss the aftercare and report the outcome.

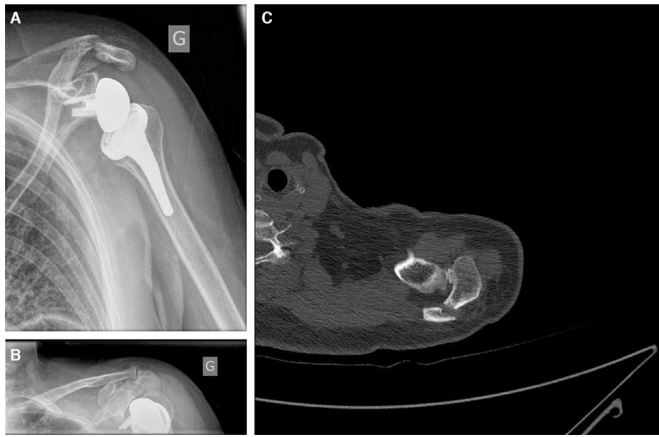
Figure 1 (A) AP plain film radiography of the shoulder showing displaced lateral scapular spine fracture at the base of acromion. (B) Plain film radiography, scapula spine view of the shoulder showing displaced lateral scapular spine fracture at the base of acromion. (C) Axial CT scan view of the shoulder showing displaced lateral scapular spine fracture at the base of acromion.

Four weeks after surgery, the patient was brought to the emergency department and admitted overnight after a fall on ice at the train station. Radiographs (figure 1A,B) and a CT scan (figure 1C) confirmed a displaced lateral SS fracture at the base of acromion¹ in a type 1 fusiform shaped SS² as seen on the radiograph (figure 1B) and as confirmed on CT scan.

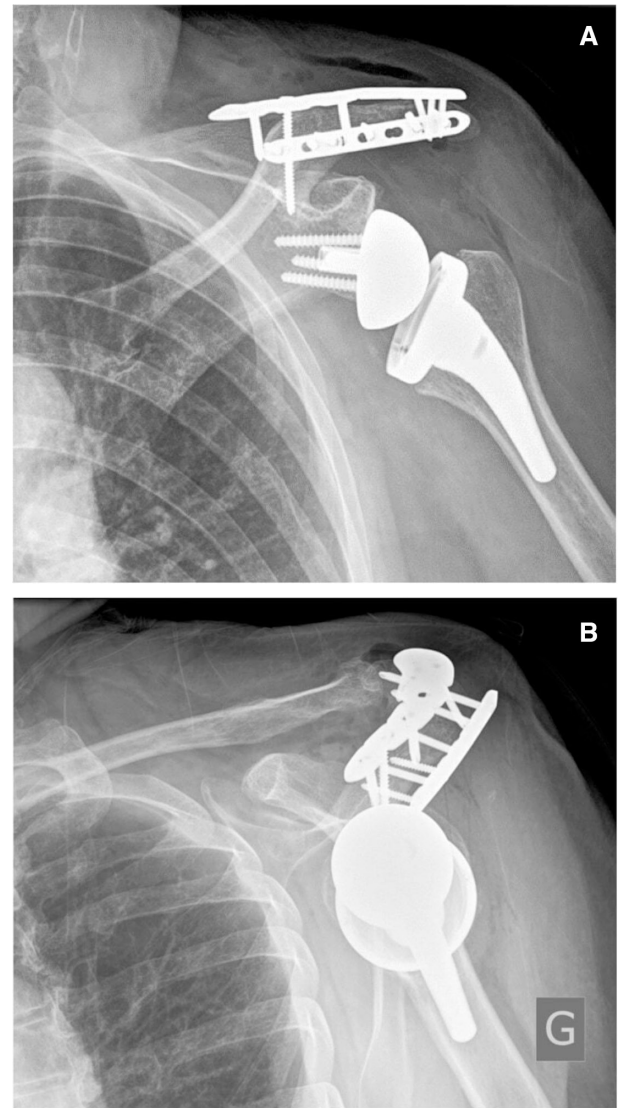
Figure 2 (A) AP plain film radiography of the shoulder, day 0 post ORIF. (B) Neer view plain film radiography of the shoulder, day 0 post ORIF. ORIF, open reduction and internal fixation.

ORIF was undertaken 1 week later (figure 2A,B). The patient was positioned 80° sitting and tilted 25° to the opposite side on a shoulder operating table with the scapula draped free on the left side. The left arm was placed in an armholder for shoulder surgery. A posterior longitudinal mediolateral incision along the SS was used and the fracture

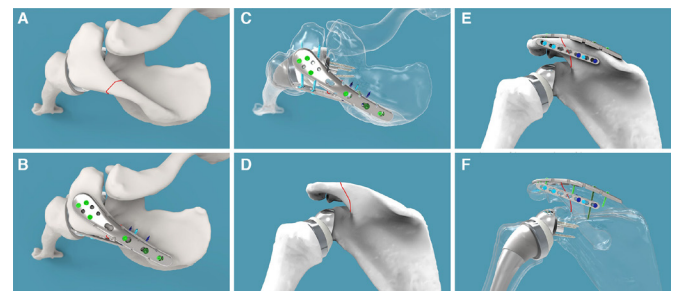
Figure 3 (A) 3D-Scapula modelling, fracture location, superior view, (B) 3D-Scapula modelling, plate and screws positioning, superior view, (C) 3D-Scapula modelling, plate and screws positioning, superior view, (D) 3D-Scapula modelling, fracture location, posterior view, (E) 3D-Scapula modelling, plate and screws positioning, posterior view and (F) 3D-Scapula modelling, plate and screws positioning, posterior view.

This case highlights that previously described 90°-double plate ORIF of the SS and acromion can be successful in achieving SS union with a pain-free outcome. The fracture in the reported case occurred early after RSA (4 weeks) after a fall. The healing potential for chronic stress and fatigue fractures or associated pseudarthroses must be considered to be lower. In these situations, we recommend debridement to bleeding bone and autologous bone grafting in addition to the double plate technique as we have successfully undertaken in an unpublished case (follow-up <6 months at this stage) and as presented but not yet published in Utah 2020 and Munich 2019 by a leading expert, Dr Ludwig Seebauer. The acromion is unforgiving regarding drilling and screw placement. We believe that lateral screw crowding (too many lateral screws) and may be an erroneous drilling attempt have led to a stress riser and a second lateral, plate adjacent fracture. Therefore exact planning of the lateral screws and their interdigitation as illustrated in **figure 3A–F**

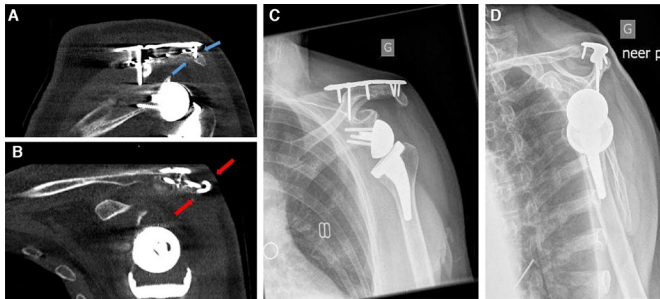
Figure 4 (A) Coronal CT scan: plate adjacent fracture of the anterolateral acromion (blue arrows). (B) Coronal CT scan: prominence of the posterolateral plate after plate adjacent fracture (red arrows). (C) AP plain film radiography of the shoulder, 1 year post-op. (D) Neer view plain film radiography of the shoulder, 1 year post-op.

outcome since this plate had become more prominent due to an inferior tilt of the anterolateral acromion (**figure 4A,B**) associated with local subcutaneous discomfort. We decided not to

remove the superior plate, which would have left the acromion and scapular spine completely unprotected with further stress risers due to empty screw holes and an increased risk for a new fracture. **Figure 4C,D** show the result after 1 year with union of the SS fracture and the plate adjacent acromion fracture. The patient was followed up more than 1 year after RSA with the following active ROM: active forward elevation: 140°; abduction: 140°; external rotation arm at side: 30°; external rotation arm elevated: 30°; internal rotation: L5. She reported no pain but slight discomfort 'feeling' her shoulder. At 6 months the subjective shoulder value (SSV) was 60% and the Constant score 56 points. At 1 year the SSV improved to 80% and the Constant score to 67 points with very good strength and no pain (Jobe Test with Micro-FT digital testing device: 16 pounds).
