# TERRESTRIAL LIDAR INVESTIGATION OF THE 2004 ROCKSLIDE ALONG PETIT CHAMPLAIN STREET, QUÉBEC CITY (QUEBEC, CANADA)

Michel Jaboyedoff, Thierry Oppikofer & Romain Minoia

In nearly 240 years 53 landslides have occurred along the Quebec City Promontory, causing 88 fatalities mainly by rockfalls. In October 2004 a rockfall reached the road close to the 1889 rockfall event which killed 35 people and injured 30 others. Using a terrestrial Lidar scanner (TLS) a 3D image was created. Seven joint sets were accurately determined in agreement with previous research. The TLS imagery permit the estimation of the volumes involved in the past instabilities and analysis of the mechanisms: a rockslide with several joint sets cutting the rock mass into parallelepiped shaped blocks. Furthermore it shows that this location is prone to future rockfall.

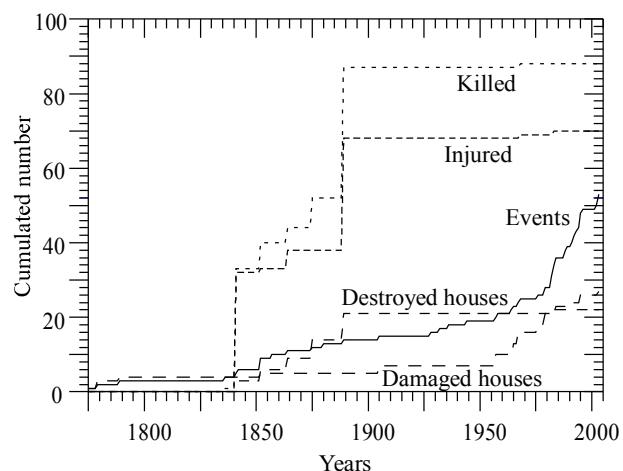
Since 1775, 53 landslides were indexed along the Quebec City Promontory, causing 88 fatalities and injuring 70 people (Figure 1). Most were related to rock instabilities, including the 1889 rockfall (35 deaths and 30 injured) that was promoted by pre-existing structures (mainly bedding and joint sets) and water seepage with an anthropogenic origin (Baillaigé, 1893; Drolet *et al.*, 1990; Evans, 1997).

Figure 1. Evolution with time of the cumulative distribution of the events and related damages along the promontory cliff (After Baillifard *et al.*, 2004a).

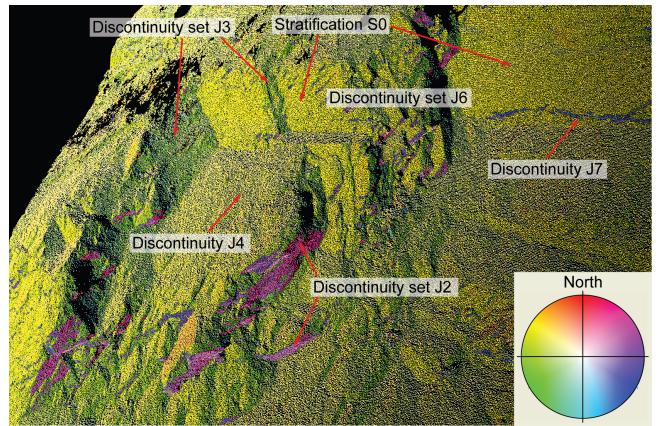
S<sub>0</sub> and J7 act as rear release surfaces and back cracks. J6, J2 and J3 form lateral release surfaces (Figures 5 and 7). These sets delimit parallelepiped shaped blocks and permit a planar sliding mechanism. Joint set J5 described by Baillifard *et al.* (2004a) is not detected, but TLS analysis allows the detection of 2 new discontinuity sets.

Figure 5. COLTOP3D colour representation of TLS point cloud and the corresponding stereonet (lower hemisphere). The mean orientation and variability of major discontinuity sets can be easily determined by their colour (Figure in colour on CD-ROM).

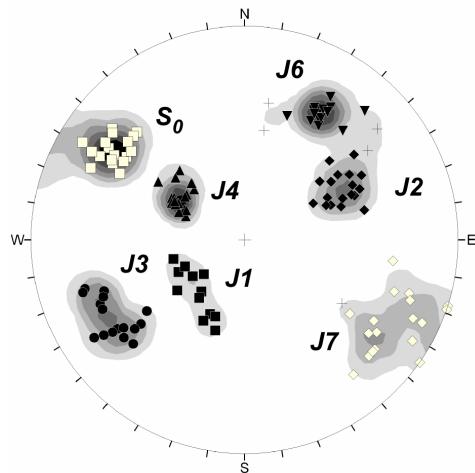
Analyses of the point clouds allow the detection of 7 joint sets including the bedding (Figures 5 and 6; Table 2). They agree closely with field investigations from Baillifard *et al.* (2004a) (Tables 1 and 2). The sliding occurs clearly on J4.

Figure 6. Lower hemisphere stereonet showing the main discontinuity sets in the study area derived from Lidar. Some non-attributed data are represented by crosses.

Figure 6 shows that TLS methods lead to homogeneous discontinuity data sets. These data must be reinterpreted because sets like  $J_1$  and  $J_3$  are certainly the same fabric and probably represent the refraction of a foliation. Such phenomenon is inferred from outcrop inspection in Figure 7. Nevertheless, such a TLS study allows easy identification and characterization of the failure mechanism. As shown by Baillaigé (1893) for the 1889 event, water is suspected to play an important role in the destabilisation of
